**Flood Control Project Maintenance
Levee Inspections**
LMA District Cover Sheet
Spring 2019 Levee Inspection Results

Reclamation District No. 2085 Kasson

Spring 2019 Levee Inspection Results

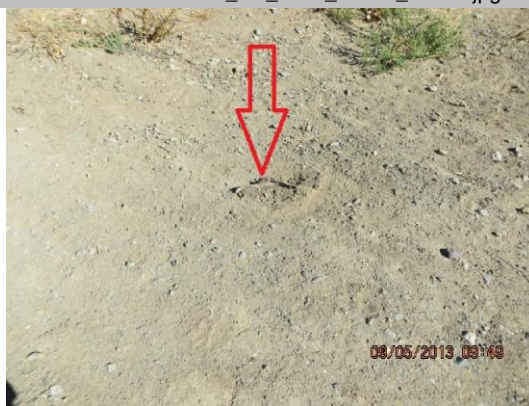
Photo 3 of 3 : UCIP_SP_2019_52493_62260.jpg

Siphon breaker in 24-inch CMP riser on WS shoulder was removed by LMA.

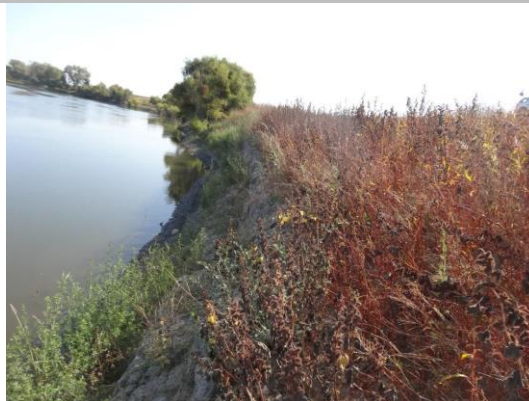
Photo 1 of 4 : SP_2019_RD2085_113_1_20190313_00001.jpg

Looking upstream at the erosion site. Note the dense vegetation and the trees at the upstream of the erosion.

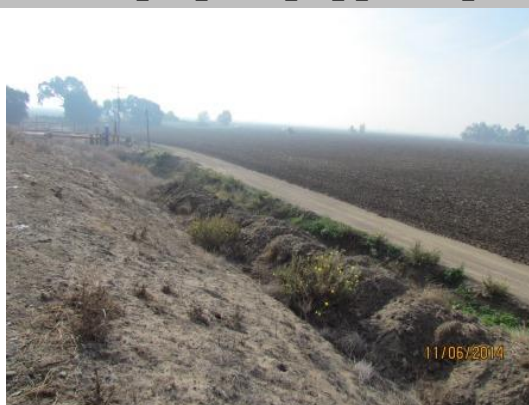
Photo 1 of 1 : SP_2019_RD2085_113_6_20190313_00010.jpg

LM Start	1.34	Rating **	M	Issue No.	6
LM End	1.38	Issue Type +	En	Location *	LS
Category	Earthen Levee			GPS Latitude/Longitude	
				Start	End
Item	Encroachments			37.714265 °	37.714056 °
				-121.289641 °	-121.289069 °
DWR ID	DWR_RD2085_01_s_2012_6				
Comment Code					
DT : Ditch					
Inspector Comment					
A drainage ditch is located at the levee toe.

View of the ditch at the landside levee toe.

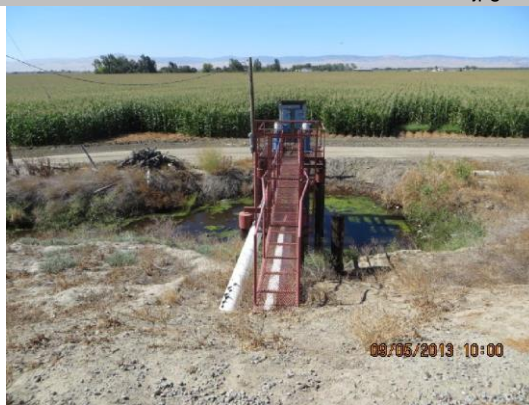
Photo 2 of 3 : UCIP_SP_2019_22285_38009.jpg

Pipe, pump, and walkway visible on LS toe.

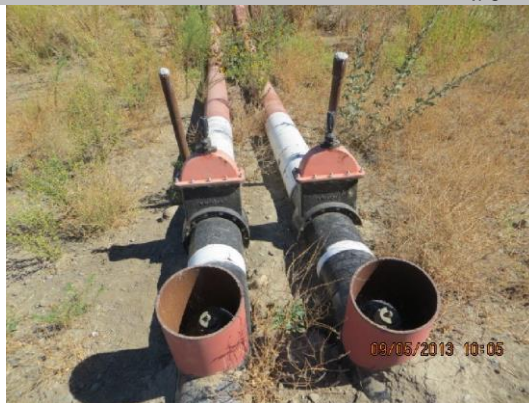
Photo 3 of 3 : UCIP_SP_2019_22285_38008.jpg

Pipe, gate valve, and siphon breaker visible on WS slope.

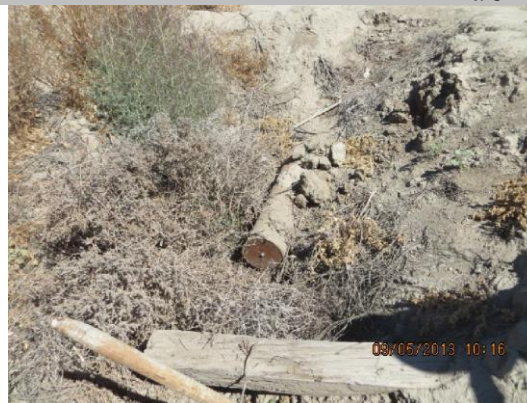
Photo 3 of 3 : UCIP_SP_2019_41351_62266.jpg

Pipe visible at bottom of ditch on LS toe.

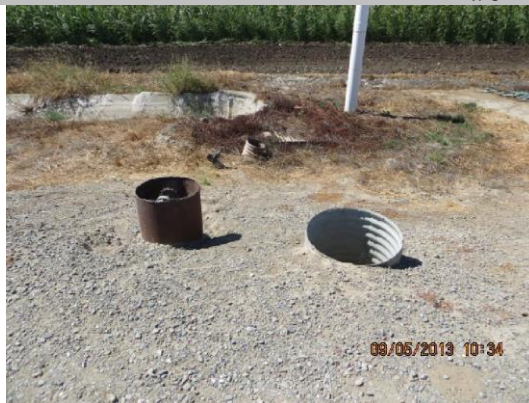
Photo 1 of 3 : UCIP_SP_2019_19423_32962.jpg

LM Start	2.04	Rating **	M	Issue No.	54
LM End	2.04	Issue Type +	En	Location *	
Category	Supplemental			GPS Latitude/Longitude	
				Start	End
Item	DWR UCIP Field Study			37.708826 °	37.708826 °
				-121.279271 °	-121.279271 °
DWR ID	20681				
Comment Code					
Inspector Comment					
FS_ID:19423 DS_ID:20681 EP_NO: N/A Repair Type: Non-Urgent Crossing Status: Found UCIP Comments: This pipe is abandoned and should be done so properly. FIELD_STRUCT_DESC: 1 of 2: 10-inch pipe through the levee 2.0-feet below the crown. Pump mounted on pile structure in the river. Siphon breaker in 24-inch CMP riser on the LS slope. Power pole on LS toe. Wooden stairs and walkway from the berm to the pump structure. Originally included in the 1968 O&M manual. FS Date: 9/5/2013 8:22:24 AM

Siphon breaker in 24-inch CMP riser on LS slope. Possible gate valve at end of concrete channel on LS toe.

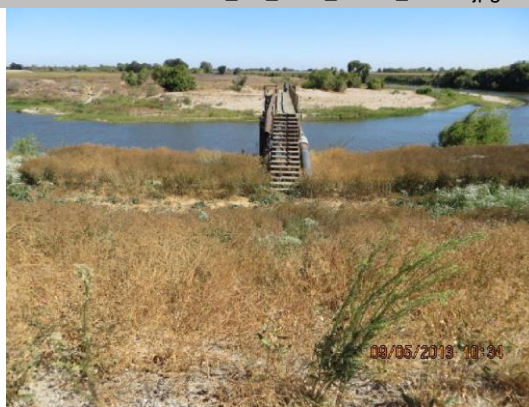
Photo 2 of 3 : UCIP_SP_2019_19423_32961.jpg

Pipe cut at wooden pier. No pump on end of pier for this pipe.

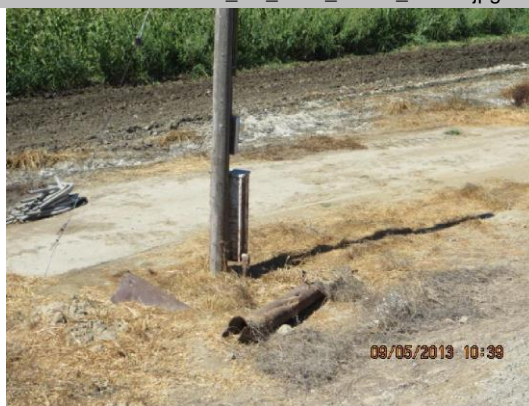
Photo 3 of 3 : UCIP_SP_2019_19423_32960.jpg

Power pole on LS toe.

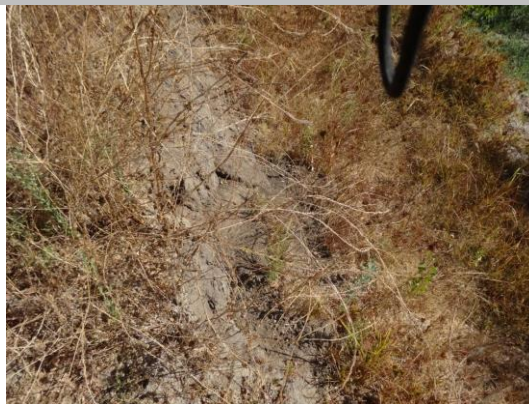
Photo 2 of 4 : SP_2019_RD2085_113_2_20190313_00006.jpg

Close view of the erosion.

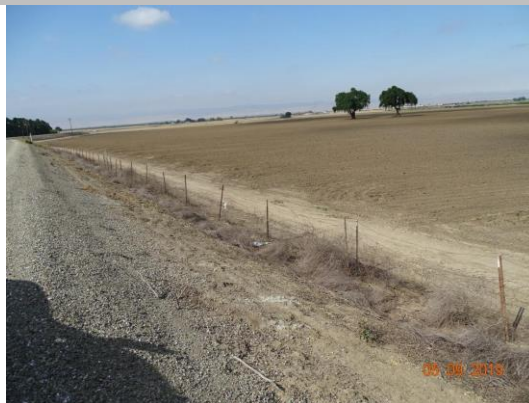
Photo 1 of 1 : SP_2019_RD2085_113_42_20190514_00060.jpg

View of barbed wire fence on landside toe. (Spring 2019)

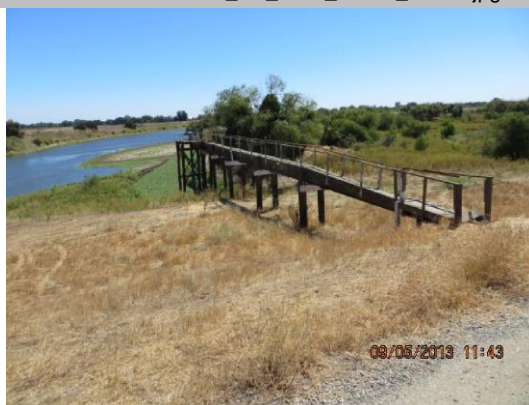
Photo 1 of 3 : UCIP_SP_2019_19431_32983.jpg

LM Start	2.82	Rating **	M	Issue No.	55
LM End	2.82	Issue Type +	En	Location *	
Category	Supplemental			GPS Latitude/Longitude	
				Start	End
Item	DWR UCIP Field Study			37.699698 °	37.699698 °
				-121.276325 °	-121.276325 °
DWR ID	20688				
Comment Code					
Inspector Comment					
FS_ID:19431					
DS_ID:20688					
EP_NO: 16970					
Repair Type: Non-Urgent					
Crossing Status: Found					
UCIP Comments: The wooden walkway on the WS slope is in disrepair.					
FIELD_STRUCT_DESC: 1 of 2: 14-inch steel irrigation pipe through the					
levee, 2 feet below the crown. Pump on wooden pier on the waterside					
(WS) slope. Siphon breaker visible next to steel bollard on the landside					
(LS) slope. Power pole on the LS toe. [Additional Reference(s): USACE					
San Joaquin O&M Manual 11, 1968, (HLM 2.74)].					
FS Date: 9/5/2013

Pump on Wooden pier at WS slopoe.

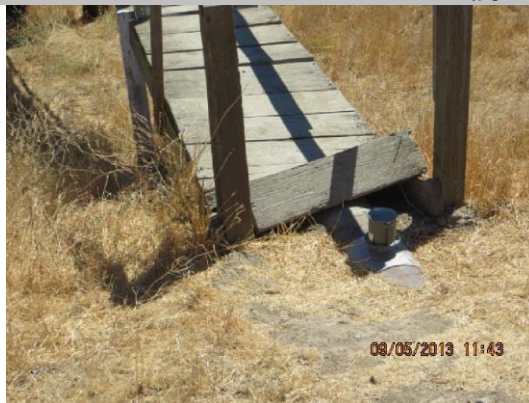
Photo 2 of 3 : UCIP_SP_2019_19431_32982.jpg

Pipe visible under walkway on WS slope.

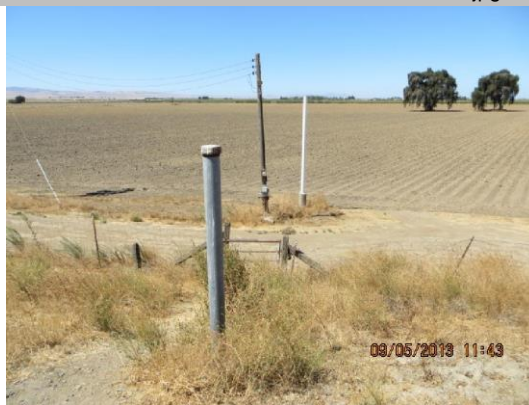
Photo 3 of 3 : UCIP_SP_2019_19431_32981.jpg

Power pole on LS toe with possible PVC riser.

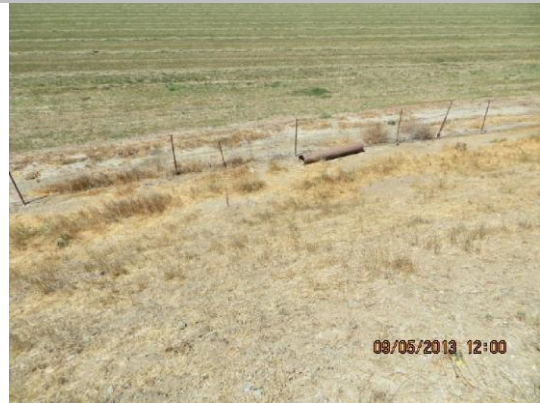
Photo 1 of 3 : UCIP_SP_2019_19433_32990.jpg

T-post marking pipe end on LS toe. 10-inch pipe debris on LS toe.

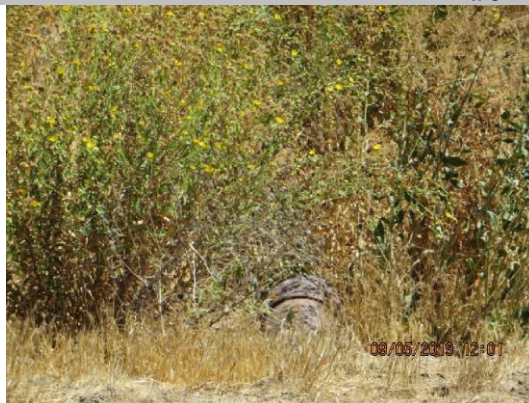
Photo 2 of 3 : UCIP_SP_2019_19433_32989.jpg

Pipe visible on WS slope.

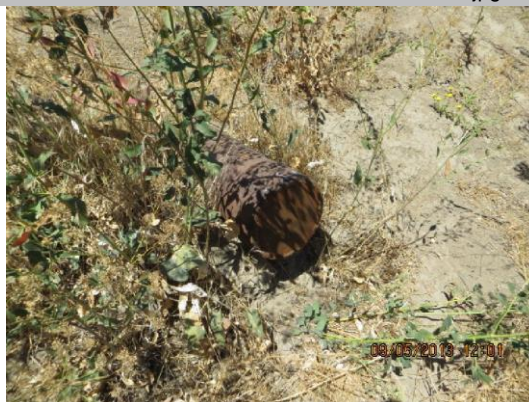
Photo 3 of 3 : UCIP_SP_2019_19433_32988.jpg

Pipe visible on WS slope. Steel plate welded over end.

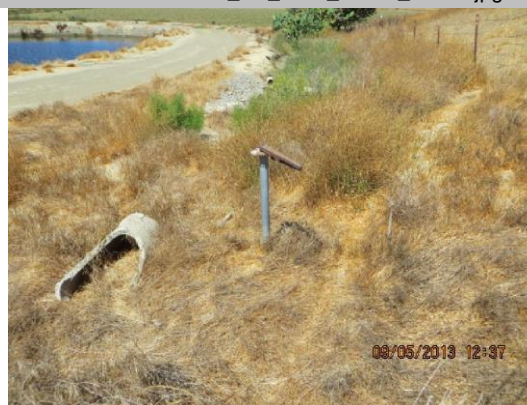
Photo 1 of 3 : UCIP_SP_2019_19435_32993.jpg

LM Start	3.42	Rating **	M	Issue No.	57
LM End	3.42	Issue Type +	En	Location *	
Category	Supplemental			GPS Latitude/Longitude	
				Start	End
Item	DWR UCIP Field Study			37.691966 °	37.691966 °
				-121.278122 °	-121.278122 °
DWR ID	20687				
Comment Code					
Inspector Comment					
FS_ID:19435 DS_ID:20687 EP_NO: 16970 Repair Type: Non-Urgent Crossing Status: Found UCIP Comments: Appears abandoned and if so should be done so properly. FIELD_STRUCT_DESC: *ABANDONED* 2 of 2: 10-inch steel drainage pipe through the levee, 2 feet below the crown. Appears to connect to pump 150 feet off the landside (LS) toe. Possible butterfly valve at the LS toe. Vent on the waterside (WS) shoulder. Steel plate welded over pipe end on the WS toe. FS Date: 9/5/2013

Possible Butterfly valve at LS toe.

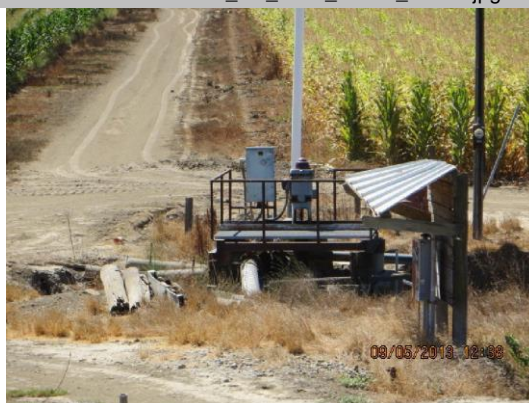
Photo 2 of 3 : UCIP_SP_2019_19435_32992.jpg

Possible connection at pump 150-feet off LS toe.

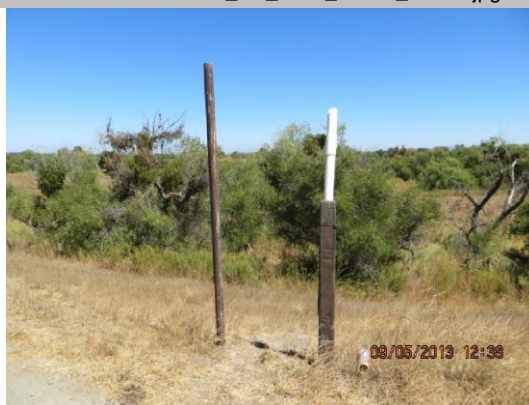
Photo 3 of 3 : UCIP_SP_2019_19435_32991.jpg

Vent on WS shoulder.

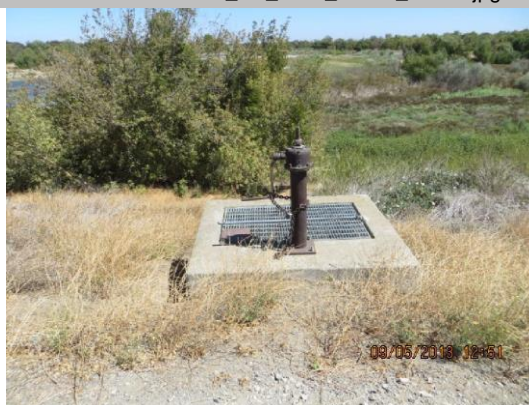
Photo 1 of 3 : UCIP_SP_2019_19436_32997.jpg

Slide gate in Concrete riser on WS shoulder.

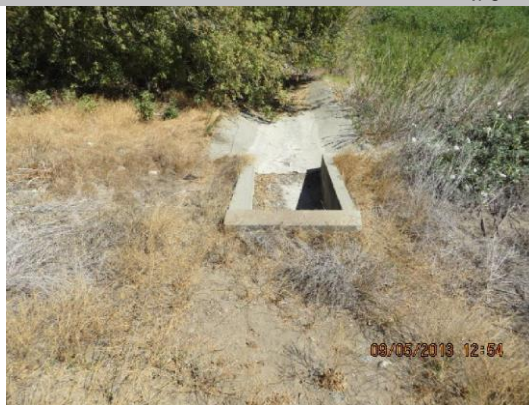
Photo 3 of 3 : UCIP_SP_2019_19436_32995.jpg

Concrete U-shaped headwall on WS slope.

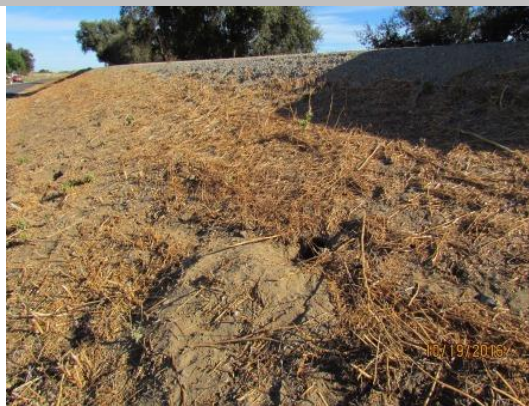
Photo 1 of 1 : SP_2019_RD2085_113_36_20190313_00020.jpg

View of the rodent holes on the levee slope.

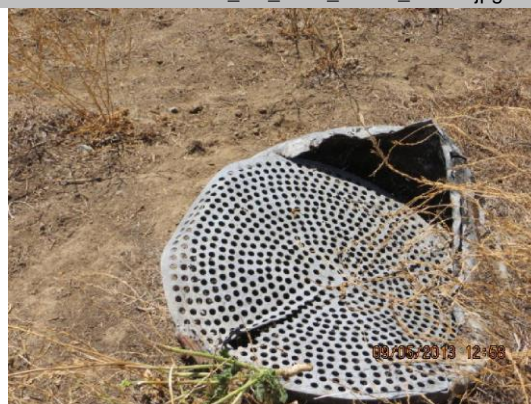
Photo 2 of 3 : UCIP_SP_2019_19443_33001.jpg

Siphon breaker on vent in 24-inch CMP riser on LS shoulder.

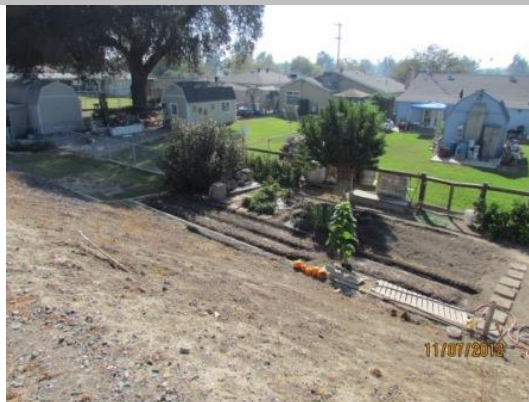
Photo 1 of 2 : SP_2019_RD2085_113_33_20190313_00018.jpg

Photo of encroachments on landside toe.

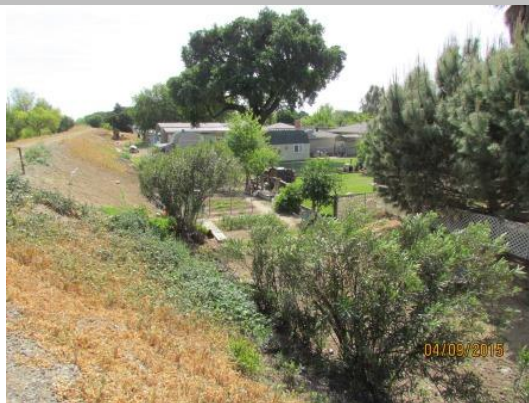
Photo 2 of 2 : SP_2019_RD2085_113_33_20190313_00019.jpg

View of the landscaping at the landside levee slope.

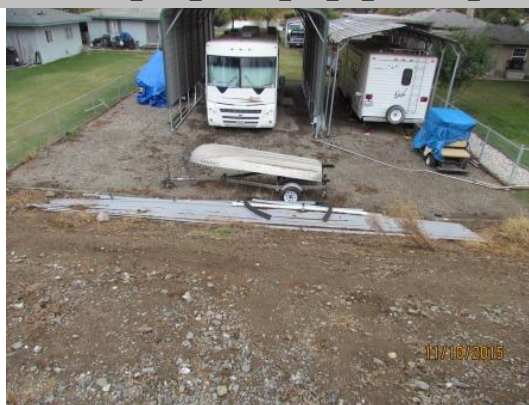
Photo 1 of 1 : SP_2019_RD2085_113_27_20190313_00014.jpg

View of the material stored at the landside levee toe.

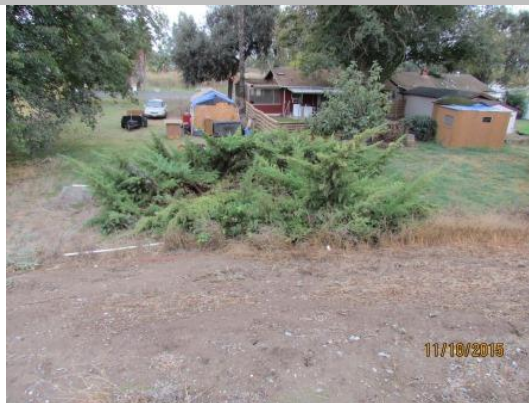
Photo 1 of 1 : SP_2019_RD2085_113_28_20190313_00015.jpg

View of the unmaintained vegetation at the landside levee toe.

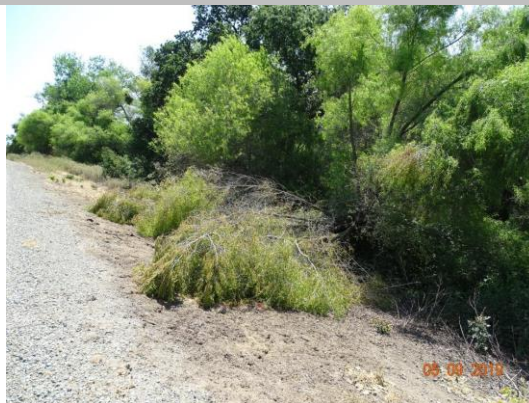
Photo 1 of 1 : SP_2019_RD2085_113_44_20190514_00061.jpg

Broken tree limb on waterside slope. (Spring 2019)

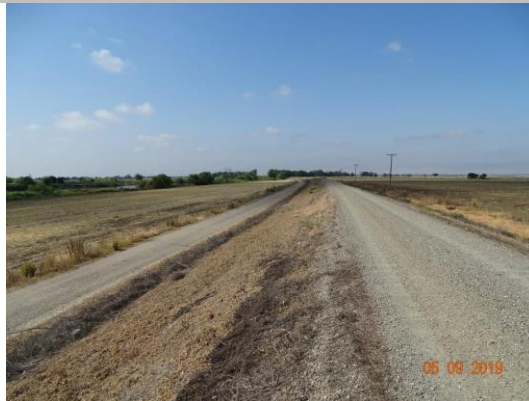
Photo 1 of 1 : SP_2019_RD2085_114_3_20190514_00001.jpg

Typical view of vegetation on waterside slope. (Spring 2019)

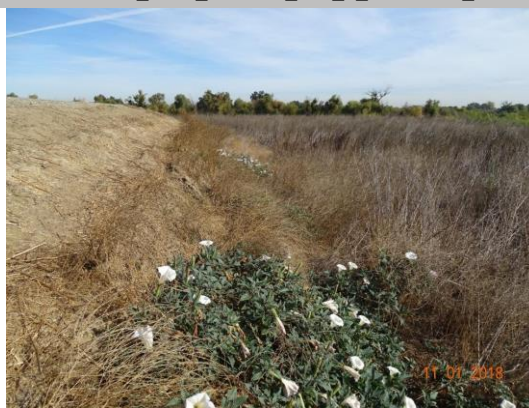
Photo 1 of 4 : SP_2019_RD2085_115_1_20190313_00001.jpg

View of erosion on the waterside slope. Fall 2018.

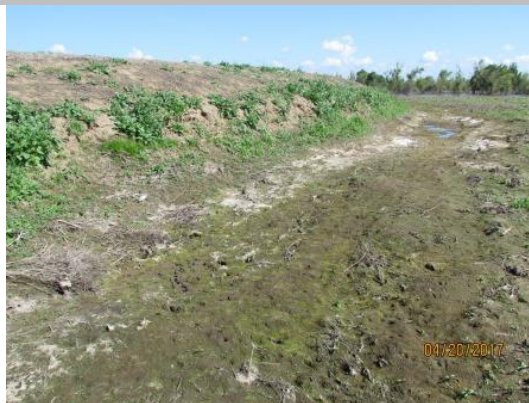
Photo 2 of 4 : SP_2019_RD2085_115_1_20190313_00002.jpg

View of the erosion at the waterside levee toe. Spring 2017.

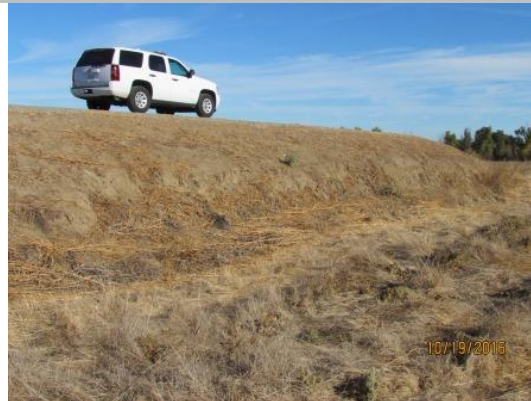
Photo 3 of 4 : SP_2019_RD2085_115_1_20190313_00003.jpg

View of the erosion at the waterside levee toe. Fall 2016.

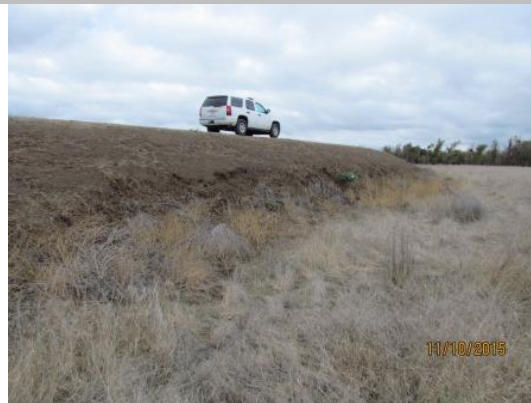
Photo 4 of 4 : SP_2019_RD2085_115_1_20190313_00004.jpg

View of the erosion at the waterside levee toe.
